Troubleshooting V-ribbed Belt Noise

Terms such as chirp, squeal, rumble and yelp have been used in the automotive industry to describe noises caused by friction-induced vibration in engine accessory drive belts. The following report, based on testing by Gates Corporation, examines primary causes and remedies for this problem.

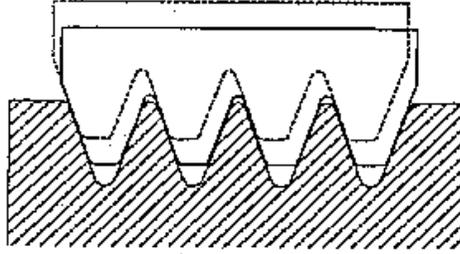
Figure 1

All sounds that are audible to the human ear have their origins in some vibrating surface. For example, intermittent chirping that increases in frequency as the engine is revved up can be the result of belt vibration caused by misaligned drive pulleys -- a leading cause of belt noise. As a misaligned V-ribbed belt span enters the grooves of

a pulley, initial contact is made with only one side of the V-groove. The greater the misalignment angle, the greater the radial sliding length experienced by the belt ribs as the belt seats in the pulley causing frictional vibrations, or chirping (see Figure 1).

Radial sliding motion of V-ribbed belt.

In the case of severe misalignment, repositioning of drive components using shims, or by changing the press fit of the pulley or the shaft, may be required. Pulley alignment and tension must be correct on all V-ribbed belt applications for the drive to operate properly.
