Troubleshooting V-ribbed Belt Noise

Terms such as chirp, squeal, rumble and yelp have been used in the automotive industry to describe noises caused by friction-induced vibration in engine accessory drive belts. The following report, based on testing by Gates Corporation, examines primary causes and remedies for this problem.

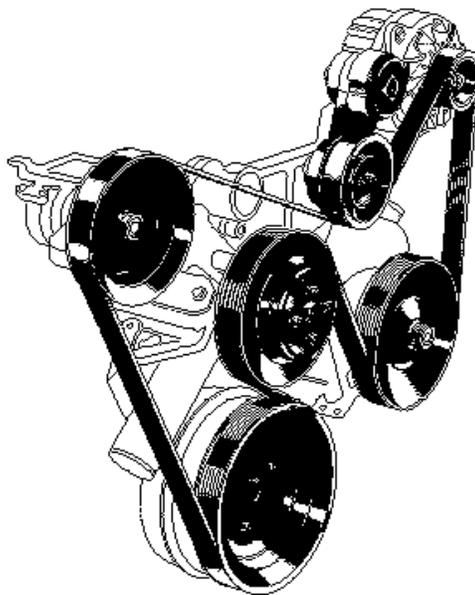
Figure 1

All sounds that are audible to the human ear have their origins in some vibrating surface. For example, intermittent chirping that increases in frequency as the engine is revved up can be the result of belt vibration caused by misaligned drive pulleys -- a leading cause of belt noise. As a misaligned V-ribbed belt span enters the grooves of

a pulley, initial contact is made with only one side of the V-groove. The greater the misalignment angle, the greater the radial sliding length experienced by the belt ribs as the belt seats in the pulley causing frictional vibrations, or chirping (see Figure 1).
